# URBAN D.C. Inc.

Marcus Garvey Park  
Mt. Morris Fire  
Watchtower

The NYC Dept. of Parks

Cast iron restoration  
& reconstruction

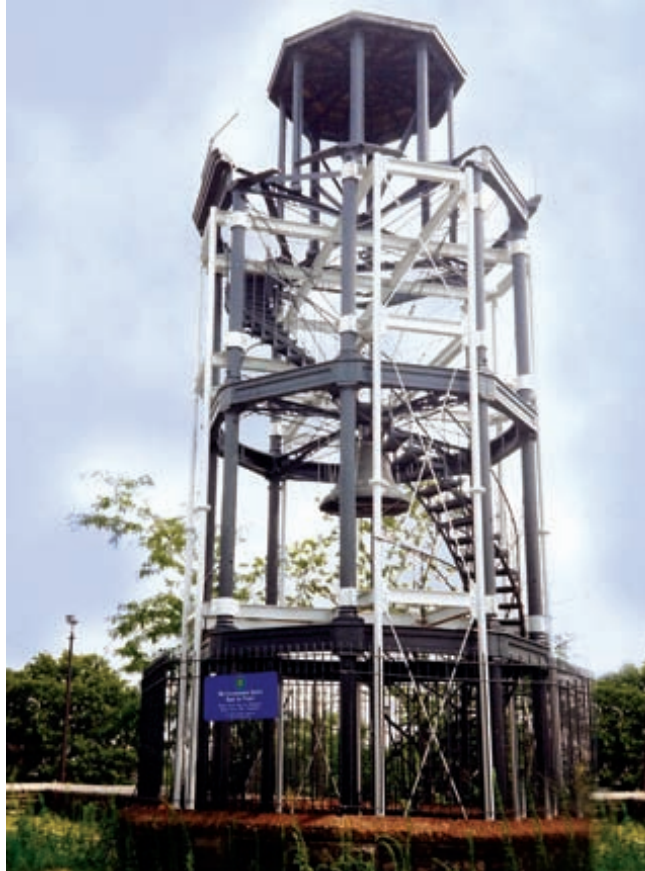
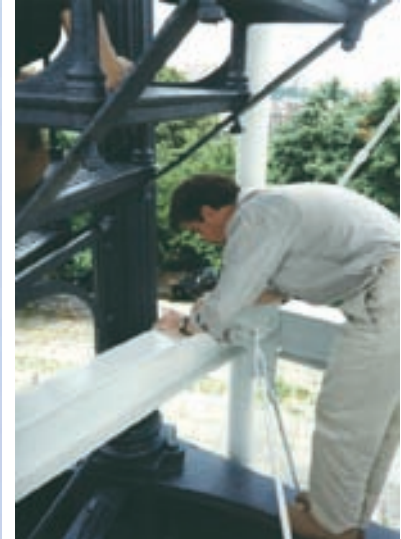
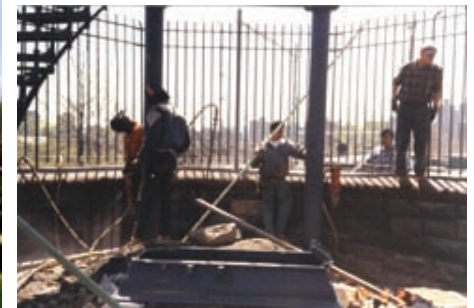
*Photos clockwise from top left. Completed structural support system. Parks Dept. representative working with Urban D.C on structural analysis. Urban D.C in-house crew underpinning the tower.*

Mt. Morris Fire Watchtower, a designated landmark, required emergency stabilization after large cast iron pieces began falling to the ground. The NYC Department of Parks hired specialty contractor Urban D.C. to stabilize the structure with an exterior steel framework. It was necessary for Urban D.C.'s in-house crew to carefully dismantle portions of the tower, in order to repair and recast various pieces around the new steel structure. This fragile structure, the century old example of "constructive expressionism," as quoted by Christopher Gray of The New York Times, was secured. Urban D.C. fabricated and installed new structural footings and finished the assignment with restorative painting.
