URBAN D.C. Inc.

St. Thomas Church
Fifth Avenue @ 53rd St.
New York, NY

Scope of Work

Stabilization of the Rose window's limestone tracery and mullions

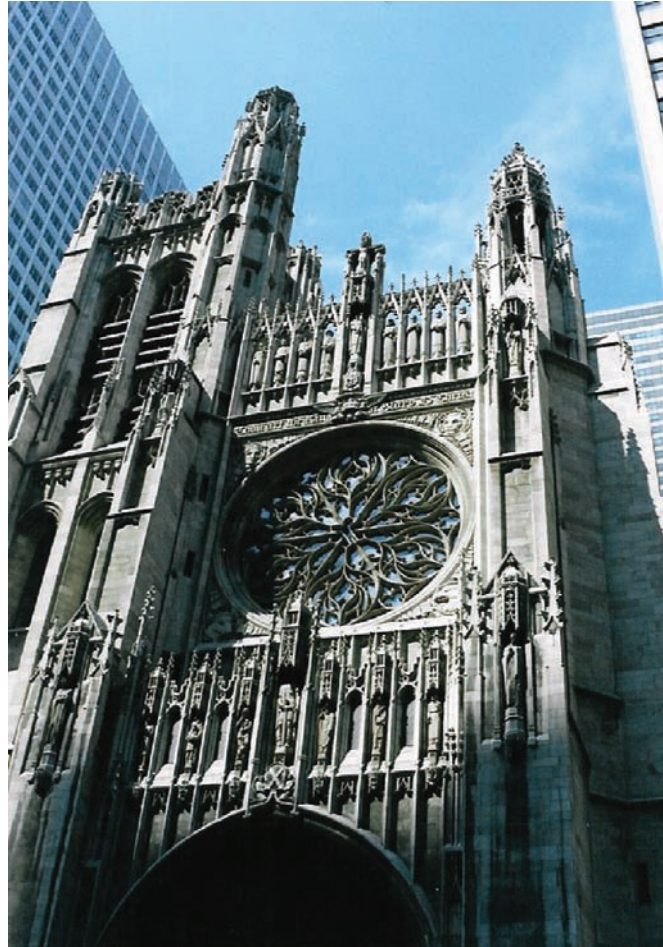
Photo left: Completed restoration of Rose window tracery at St. Thomas Church. Top right: Urban D.C. staff stabilizing the east wall ballustrade. Middle right: Pointing the tracery--exterior view. Bottom right: Pointing the tracery--interior view.

Hired by the church, Specialty contractor Urban D.C.'s primary scope of work was the stabilization of the limestone tracery and mullions holding the stained glass of the Rose window. Next was the restoration of the east wall ballustrades. Urban D.C. completed the project with the cleaning, restoration and mortar replacement of the stone ornamentation and without disrupting scheduled services.
